Smoke and Dye Testing Summary

High Level Sewershed

Test ID	Test Type	Date Inspected	Company / Super.	Blower MH	Ground Condition	Notification Made?	Total Length
S1028-264	Smoke	9/2/2009	ADS/TM	S09MM1015MH	Dry	Yes	1,879.78

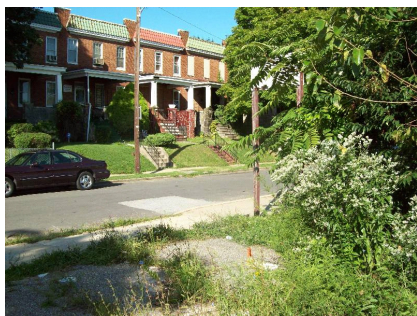
Picture \S1028-264-OB01-P01.jpg

Status Private

Source Cleanout

Location Yard - front

Comments Smoke from cleanout in front yard. 4975 Denmore Ave.

Comments Front yard, 4975 Denmore Ave.

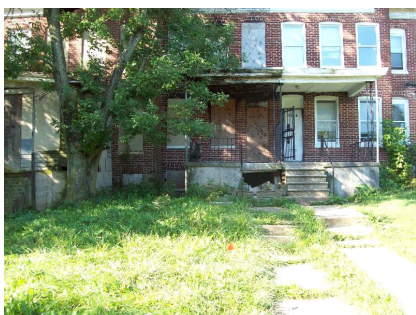
Picture \S1028-264-OB02-P01.jpg

Comments Smoke from cleanout in front yard. 4936 Denmore Ave.

Comments Front of house, 4936 Denmore Ave.

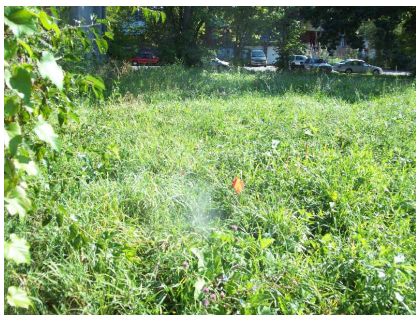
Picture \S1028-264-OB04-P01.jpg

Comments Smoke from cleanout in empty lot. 4917 Denmore Ave.

Comments Front of lot, 4917 Denmore Ave.

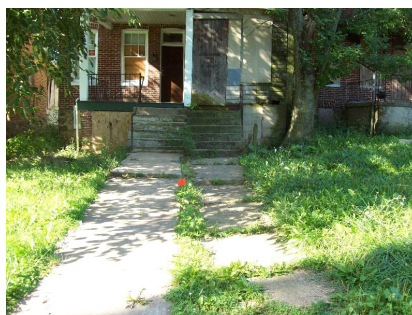
Picture \S1028-264-OB03-P01.jpg

Comments Smoke from cleanout in front yard. 4934 Denmore Ave.

Comments Front of house, 4934 Denmore Ave.

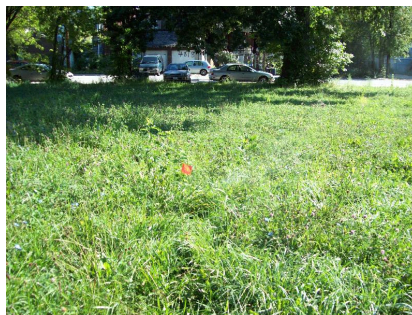
Picture \S1028-264-OB05-P01.jpg

Comments Smoke from cleanout in empty lot. 4911 Denmore Ave.

Comments Front of lot, 4911 Denmore Ave.

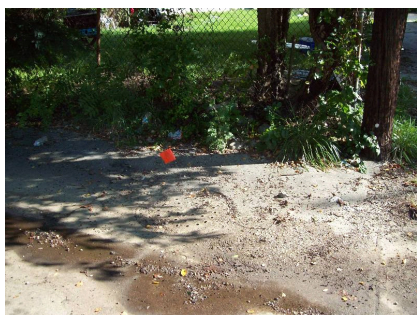
Picture \S1028-264-OB06-P01.jpg

Comments Smoke from sanitary manhole S09MM1015MH (vented cover) in paved concrete behind 4814 Park Heights Ave.

Comments Back of lot, 4814 Park Heights Ave.

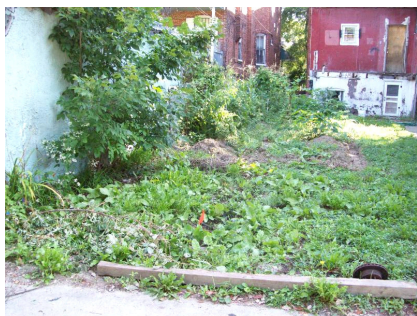
Picture \S1028-264-OB08-P01.jpg

Comments Smoke from service lateral in back yard. 4820 Park Heights Ave.

Comments Back of house, 4820 Park Heights Ave.

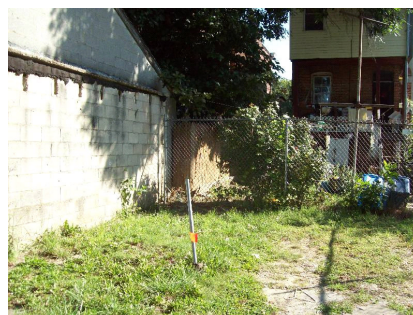
Picture \S1028-264-OB07-P01.jpg

Comments Smoke from cleanout in back yard. 4816 Park Heights Ave.

Comments Back of house, 4816 Park Heights Ave.
